Indoor air sealing repair of senior apartments | Vaasa

Project: Indoor Air Sealing

Address: Vuorikatu 2-4, Vaasa, Finland

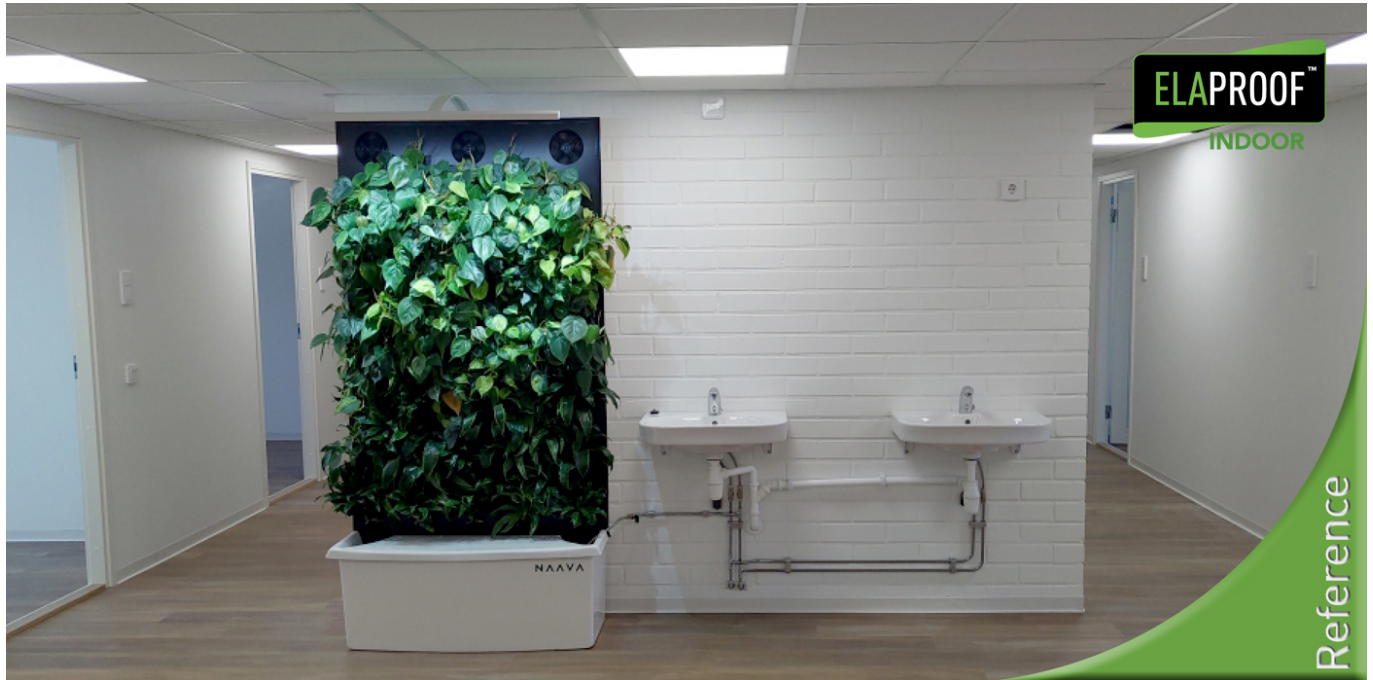
Sealing repair in connection with the basic repair: Upper floor-wall joint, hollow tile seams, penetrations, window joints and intermediate floor-wall joint.

The site is a concrete sandwich element (+cavity slab) house, which was built in 1985 as a service building. Currently, the building has senior apartments, service providers and office space.
