## Machine seam ceiling 370 m<sup>2</sup> | Turku

**Project:** Roof coating

**Address:** Kaskenkatu 4b, 20700 Turku, Finland

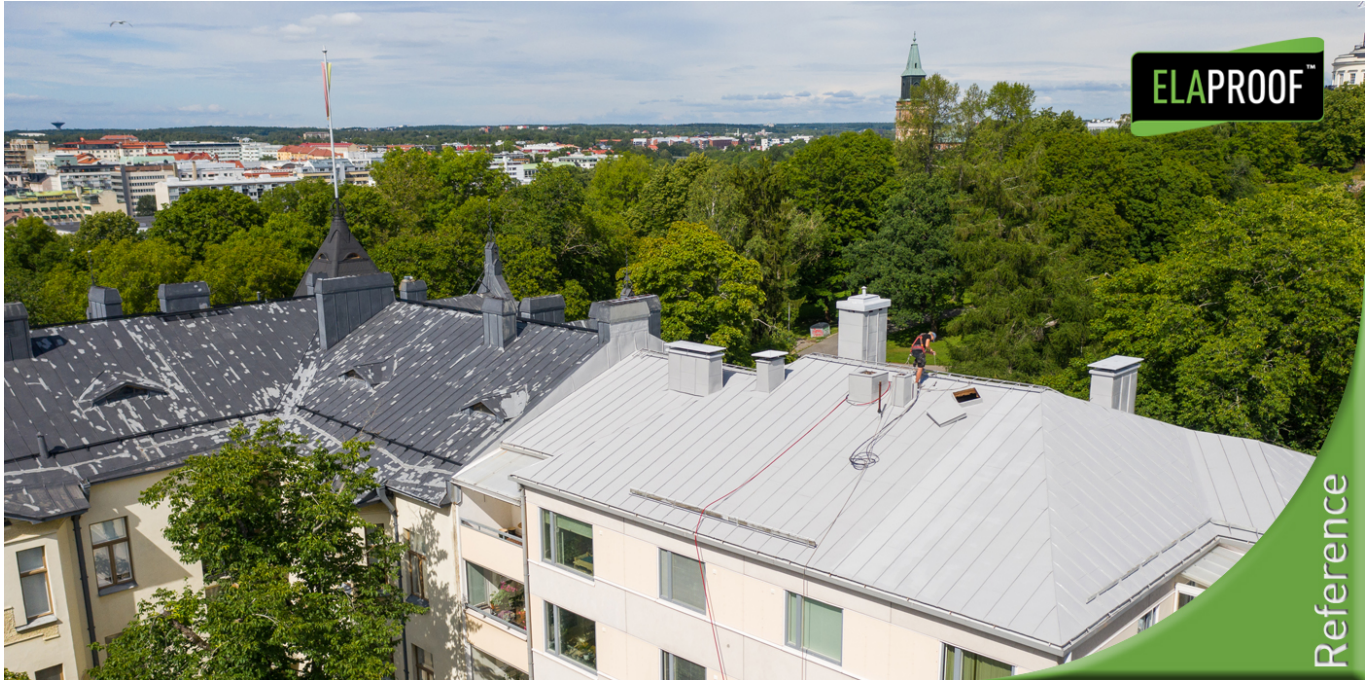
The site has a leaking and rusty machine seam roof. Before spraying ElaProof on the roof, I performed hot high-pressure washing and sanding of rust spots and pretreatment. The site was sprayed with ElaProof S twice according to the work instructions.
