# Indoor air sealing of a townhouse apartment

**Project:** Indoor Air Sealing

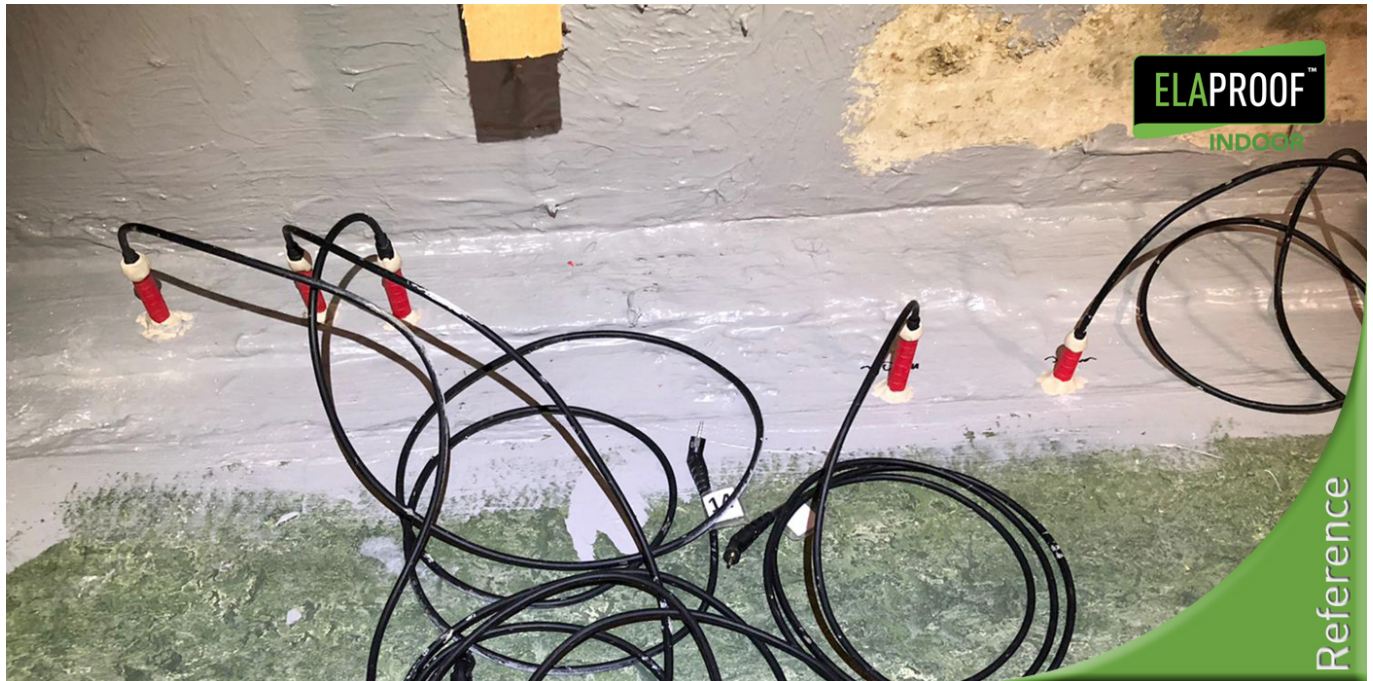
A microbial odor was detected in the indoor air of a townhouse apartment, the cause of which turned out to be a leak coming from the soil at the border between the floor and the plinth. Structure opened and microbial odorous materials removed and air leakage sealed with ElaProof Indoor. The space has been dust cleaned and ozonated. The moisture content of the structure was measured with structural moisture measurements. The renewal of the structure was carried out according to the plans.
