Indoor air sealing of office spaces | Lappeenranta

Project: Indoor Air Sealing

Address: Lappeenranta, Finland

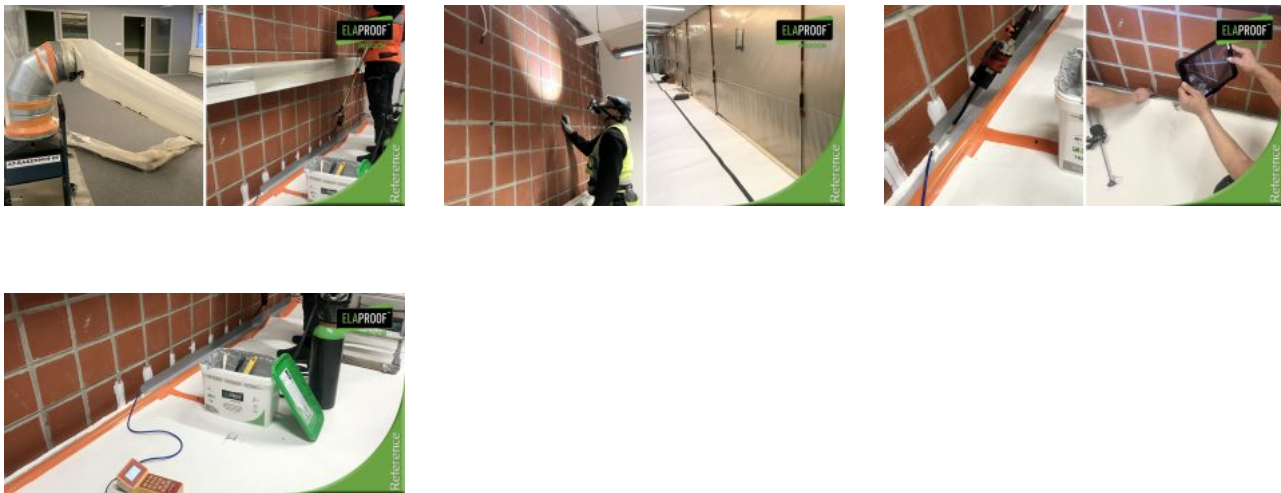
The site has a typical 1980s concrete-wool-concrete frame. The tightness of the recasts of the element joints is insufficient. By repairing them, better indoor air quality, improved thermal comfort and the building physical function of the structures are achieved.

The indoor air repair of the office premises was carried out with ElaProof products. The repair included sealing repairs to the frame structures. The goal is to secure good indoor air by repairing the element seams of the outer wall element. Quality control was performed with tracer tests. Lifetime target: 20 years
