Terrace coating 30 m² | Savonlinna

Description

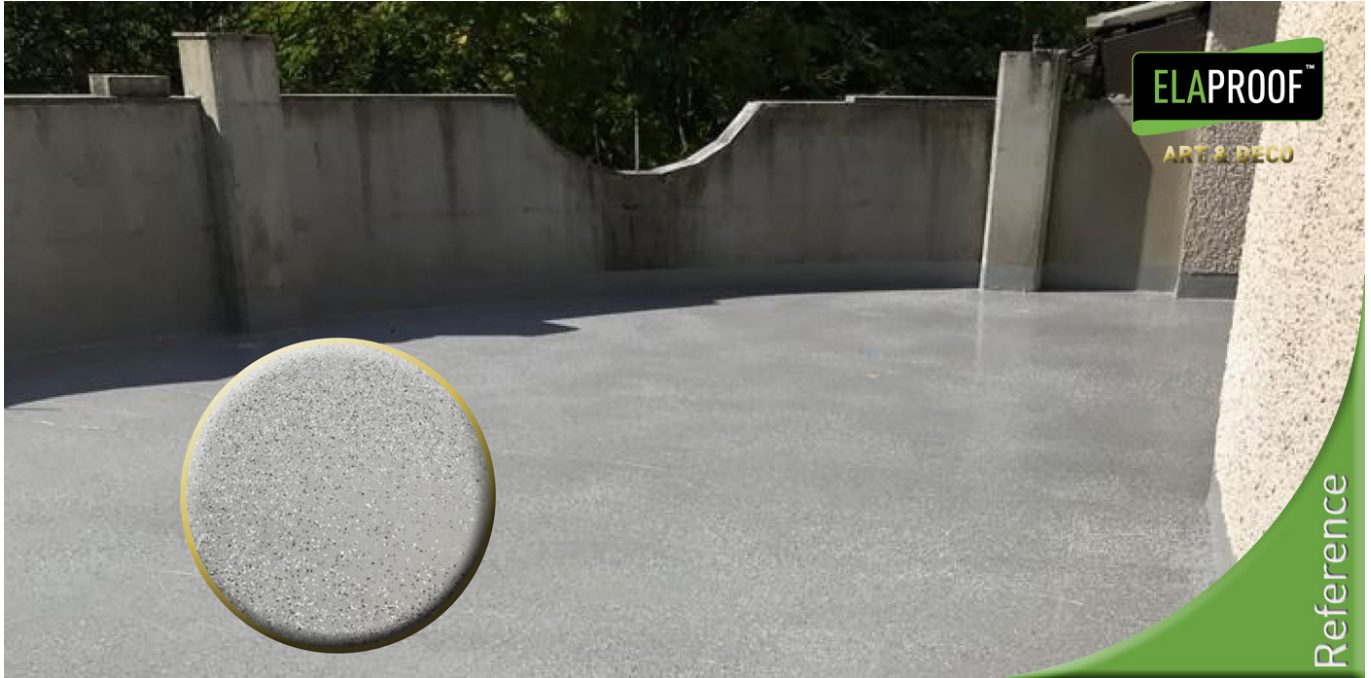
The terrace of a detached house, old tiles, some marble and some granite. The surfaces of the tiles were sanded open with a cup wheel. The surface was treated with ElaProof Primer before coating. Waterproofing was ensured with ElaProof H and ElaProof Art&Deco 3-color flakes was applied to the surface. The final surface was protected with ELACOAT TopCoat varnish.
