## Indoor air sealing of the bedroom | Helsinki

### Description

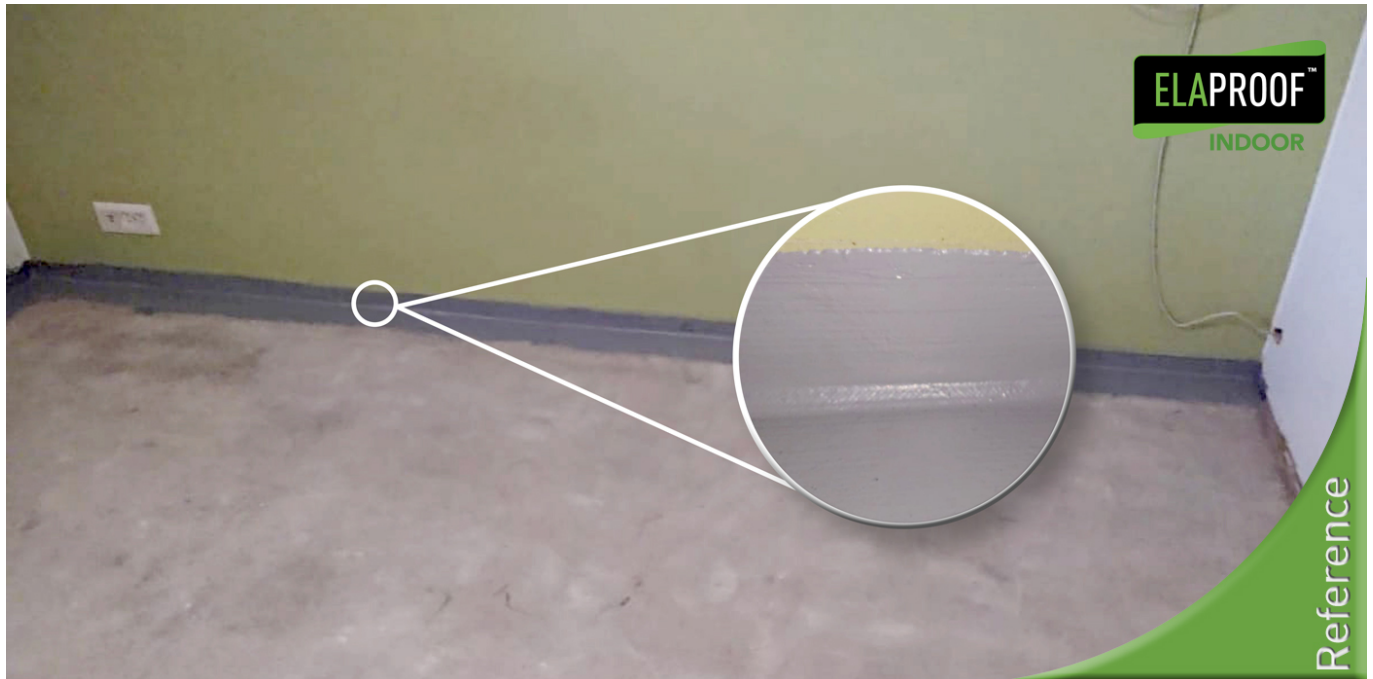
The old floor covering in the bedroom was removed and the concrete surface was roughened, after which ElaProof Primer was applied. Indoor air sealing was implemented on the two sides facing the outer wall. The work was carried out in accordance with the manufacturer's work instructions.
