# Indoor air sealing of the school building | Forssa

**Project:** Indoor Air Sealing

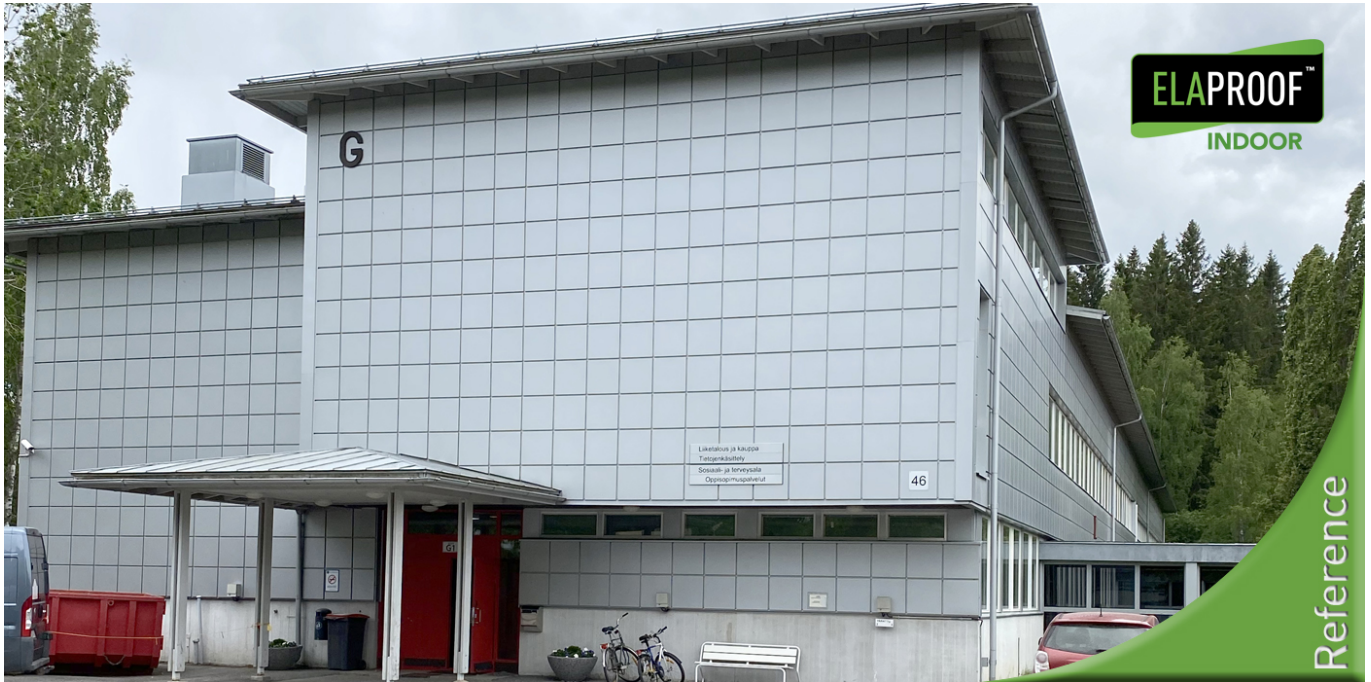
The school building has indoor air pollution and heat leaks. Floor moldings removed from the structures and larger gaps sealed with Masa sealing compound before ElaProof Indoor installation. Model sealing made after ElaProof Primer treatment, which was checked with tracer tests before starting the actual sealing work. The work has been carried out in accordance with Paloniitty Oy's plans and the work instructions of the product manufacturer.
