Machine seam roof 1200 m² | Helsinki

Project: Roof coating

Time and city: 06/2019 | Helsinki

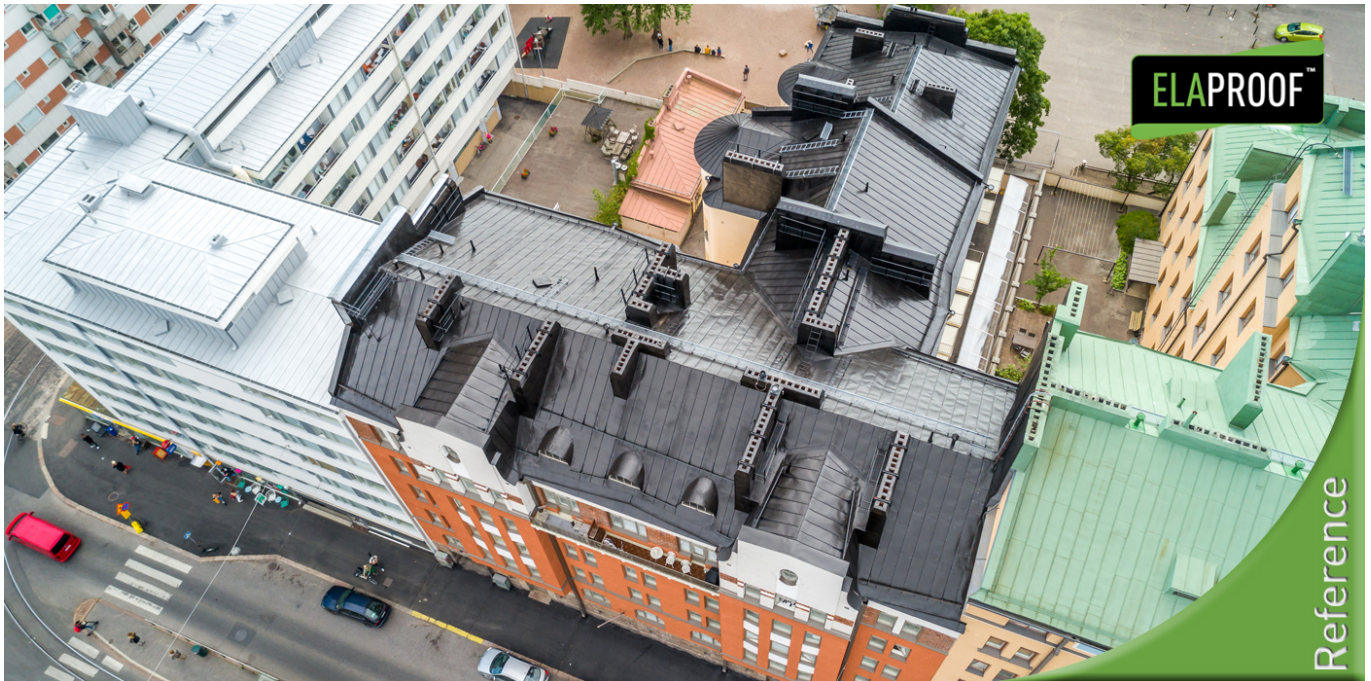
Before coating, the roof was carefully washed. In this demanding site, part of the roof had e.g. old graphite paint that was removed by dry ice blasting. Before spraying, the seams and joints were sealed with ElaProof H. The roof was sprayed with ElaProof S twice according to the work instructions.
