Machine seam ceiling 370 m² | Turku

Project: Roof coating

Address: Kaskenkatu 4b, 20700 Turku, Finland

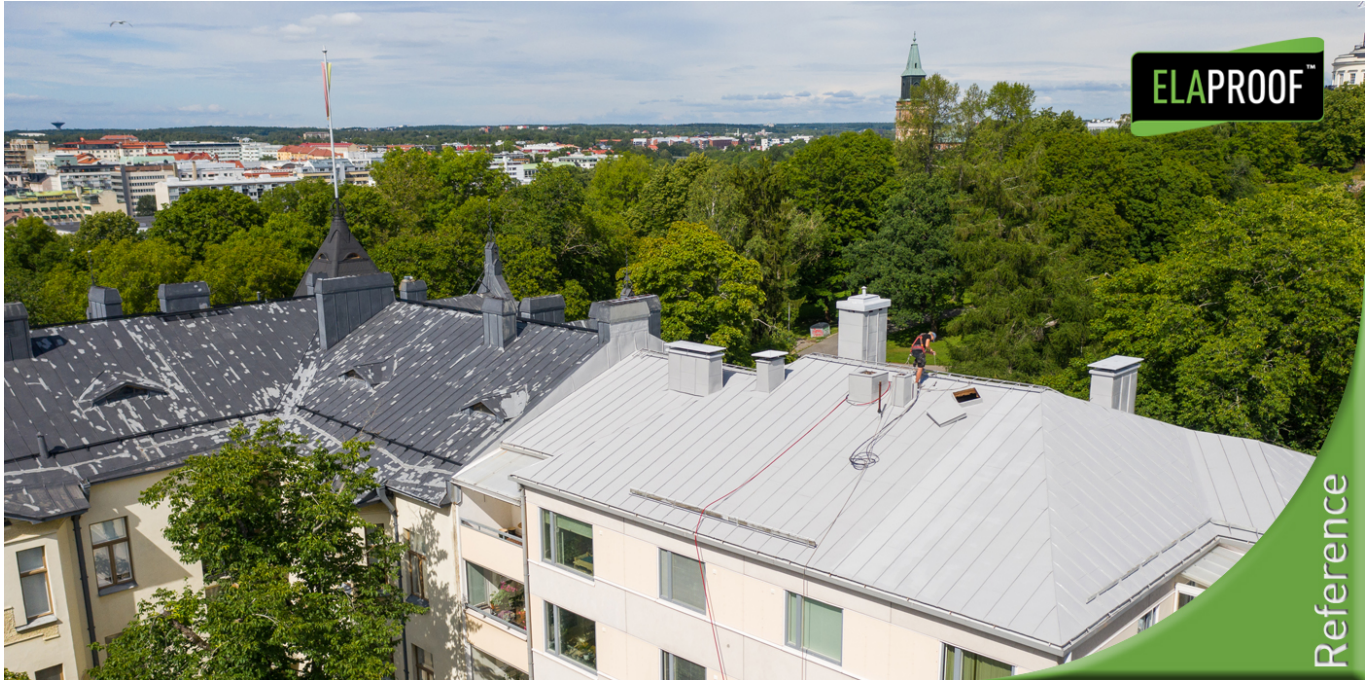
The site has a leaking and rusty machine seam roof. Before spraying ElaProof on the roof, I performed hot high-pressure washing and sanding of rust spots and pretreatment. The site was sprayed with ElaProof S twice according to the work instructions.
