Eurogum / Felt roof 3000 m² | Lieto

Client: Lieto Shopping Center
Project: Roof coating
Address: Hyvättyläntie 2, Lieto, Finland
Material: Eurogum- and felt roof
Contractor: Turun Kattopinnoite | Pasaalok Oy
Time and city: 07/2020 | Lieto

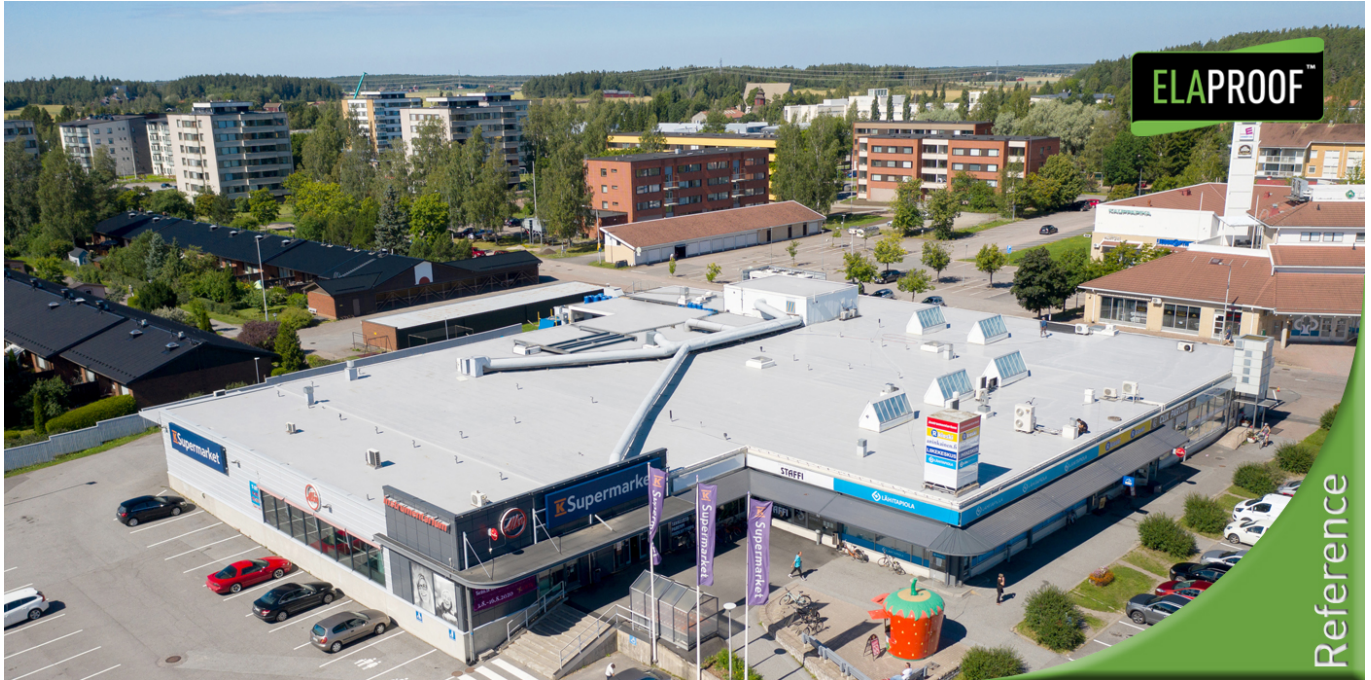
Two different roof materials are used in Lieto: Eurogum and felt roof. The roof materials have a lot of cracks, breaks and penetrations in poor condition. Hot high-pressure washing of the roof was carried out at the site, the penetrations were pre-treated with ElaProof H and ElaProof Base fabric. The ceiling was coated twice with gray ElaProof S.
